# Manhole Inspection Summary

Manhole # S29M\_\_004MH

Insp Date: **12/12/08 2:45 PM**

**Location** Address: **S MLK BD**

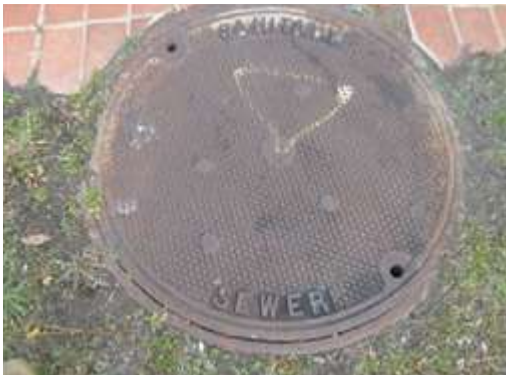
cover pic

Condition: **Sound**

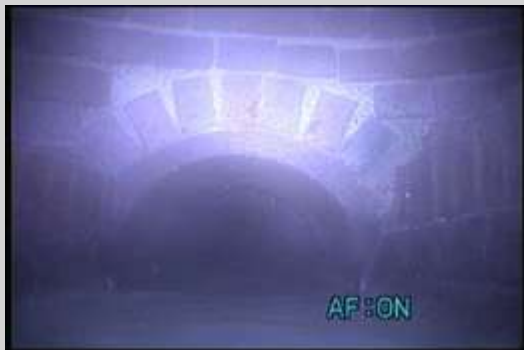
12 O'Clock Outflow

15 in. Circular Gravity Sewer  
Pipe Out @ 12 O'Clock

Pipe Height: **15.6** (in.) Rod and Bar (Angled)  
Pipe Material: **Clay** ☐ Pipe Lined  
Invert Depth: **23.00** (ft.) Flow Characteristics: **Slow**  
Deposits: ☒ None ☐ Mud ☐ Sludge ☐ Debris ☐ Grease  
Silt Depth: **0** (in.) Deposits Extent:  
Infiltration: **None** Pipe Seal Cond: **Sound**
